# Black Dog Manufacturing

## Instruction Manual Rover Engine Block Tester

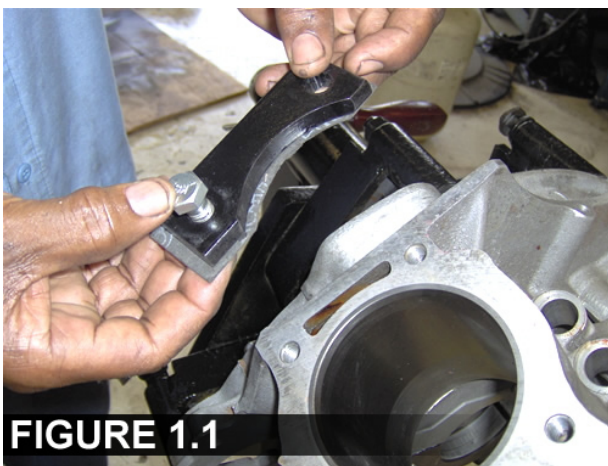
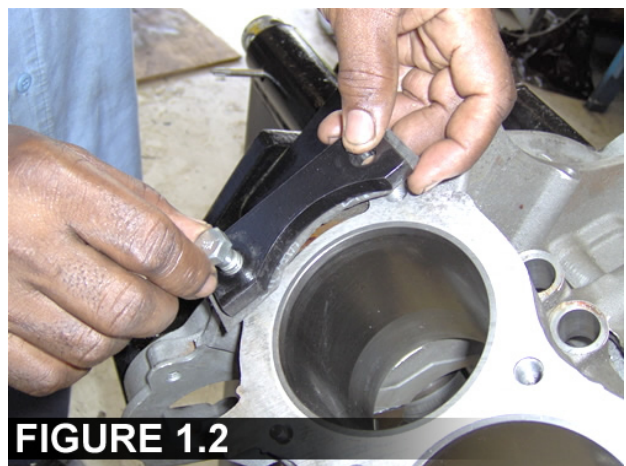
- 1) Remove both cylinder heads.
- 2) Remove the water pump.
- 3) Clean the block surface in the same manner you would to reinstall new head gaskets.
  - a. **!!!Important!!!**: Do not use high-speed discs of any kind to clean the block surface. Damage to the surface will occur and may prevent head gasket sealing.
- 4) Apply a thin coat of Permatex ultra gray around coolant port on top of the block surface. (Or you may cut a gasket to fit the plates.)
- 5) Install the Black Dog Block Off Plates to the front and back of both cylinder banks using the bolts provided. Torque the bolts to 40 foot-pounds. (Figures 1.1 and 1.2)

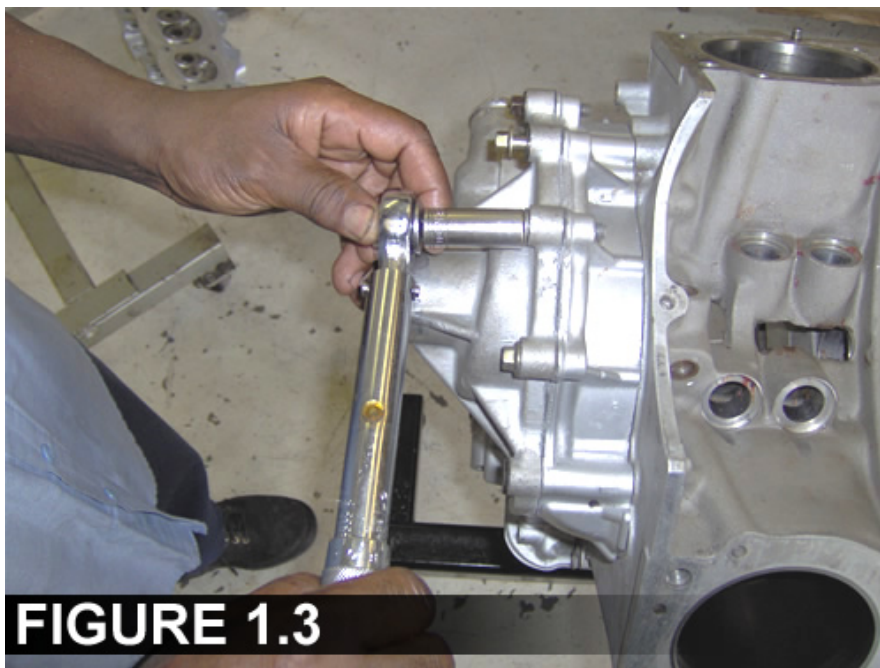
6) Install the modified water pump with gasket provided. Torque to 18 foot-pounds. (Figure 1.3)

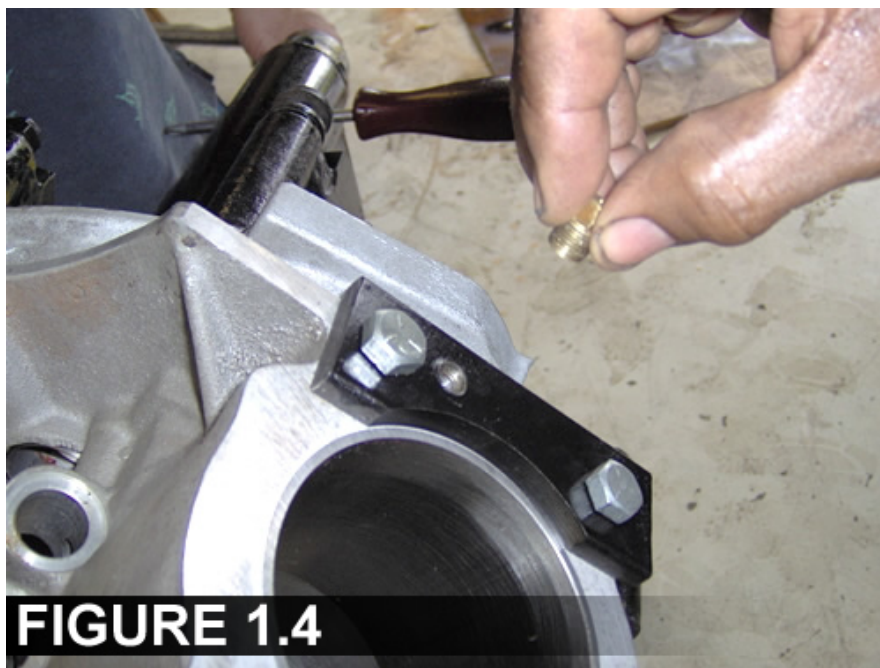
7) Fill the block with 50/50 coolant (you may re-use the old coolant) through the holes in the plates (Figure 1.4). Insure the block is completely full and that there is no air in the cooling system.

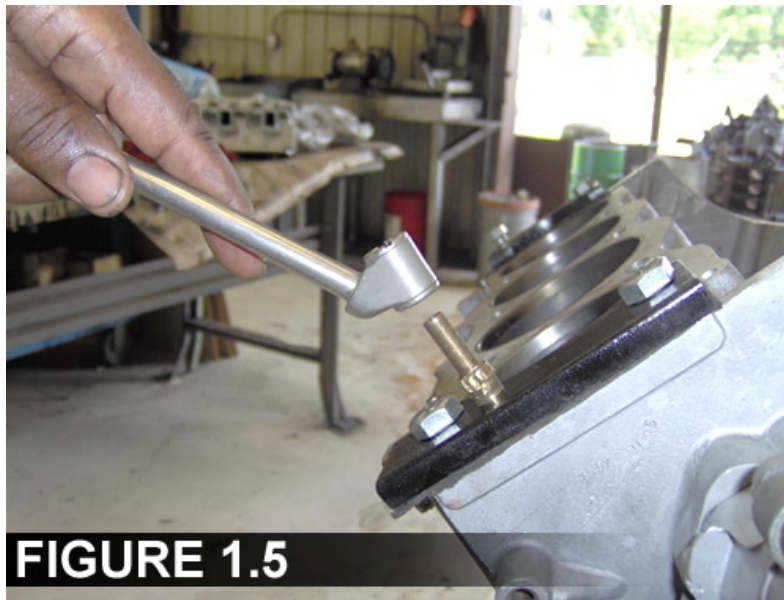
- 8) Install the plug and Schrader valve assembly into the Black Dog Block Off Plate.
- 9) Pressurize the block to 40 pounds through the Schrader valve fill port (Figure 1.5).
  - a. **!!Important!!**: Do not over pressurize.

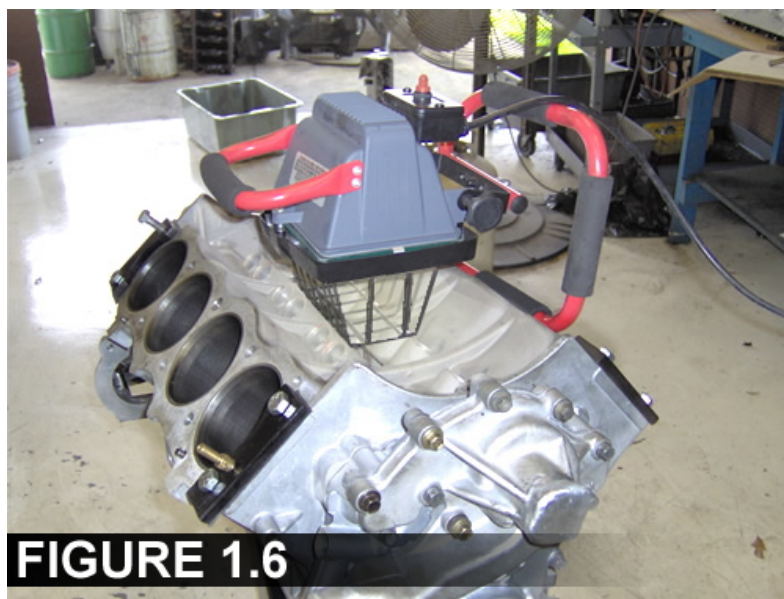
- 10) Set heat lamps on the center valley of the engine. Multiple lamps may be used. Be sure to use caution to insure that nothing comes into contact with the lamps, as the high temperature will melt plastic tubing or wire insulation (Figure 1.6).
  - a. High Intensity bulb lamps are used in construction sites as “auxiliary work lamps” and are available at your local home improvement store.
